Technical Preservation Services  
Preservation Assistance Division  
National Park Service  
U.S. Department of the Interior  
Washington, D.C.

# Interpreting the Secretary of the Interior's Standards for Rehabilitation

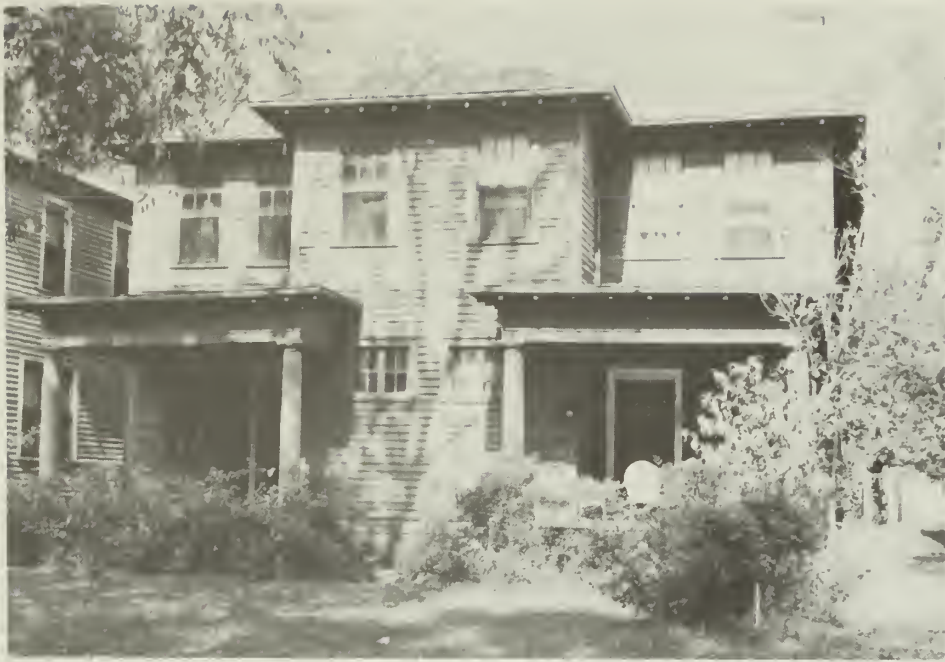
1. Prior to rehabilitation, the historic twin porch design and center projecting bay were strong architectural features.

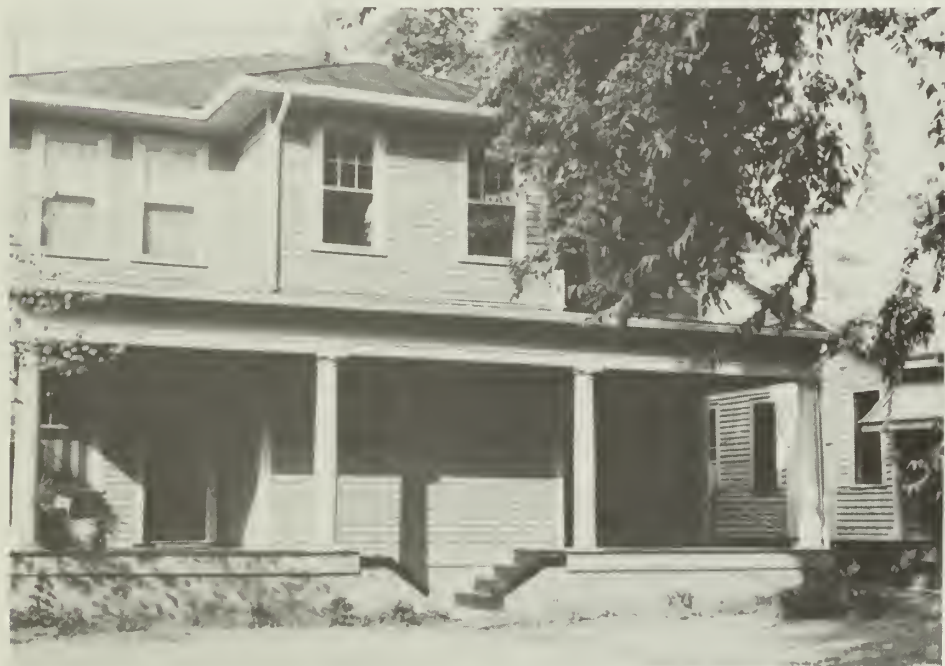
The sole justification for the porch alteration was the need to alleviate water accumulation at the steps. Traditionally, such porch roofs were pitched away from the steps and the building in order to properly shed water; the owner should have thus repaired the porch and added gutters and downspouts, as necessary, to correct the water problem.

2. In connecting the two historic porches, the twin porch design was lost; a strong horizontal element was created by the large continuous porch; and the sense of a duplex building was diminished. To obtain certification, the owner agreed to restore the porch.

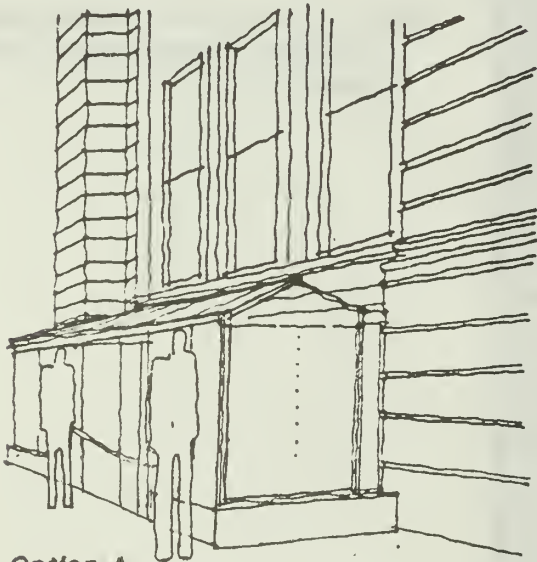
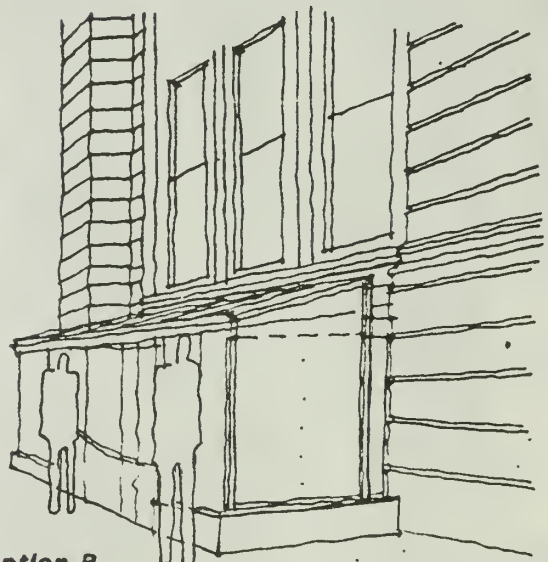
5. Final canopy designs (Option A and B), both of which NPS approved. The Option A design was ultimately constructed.

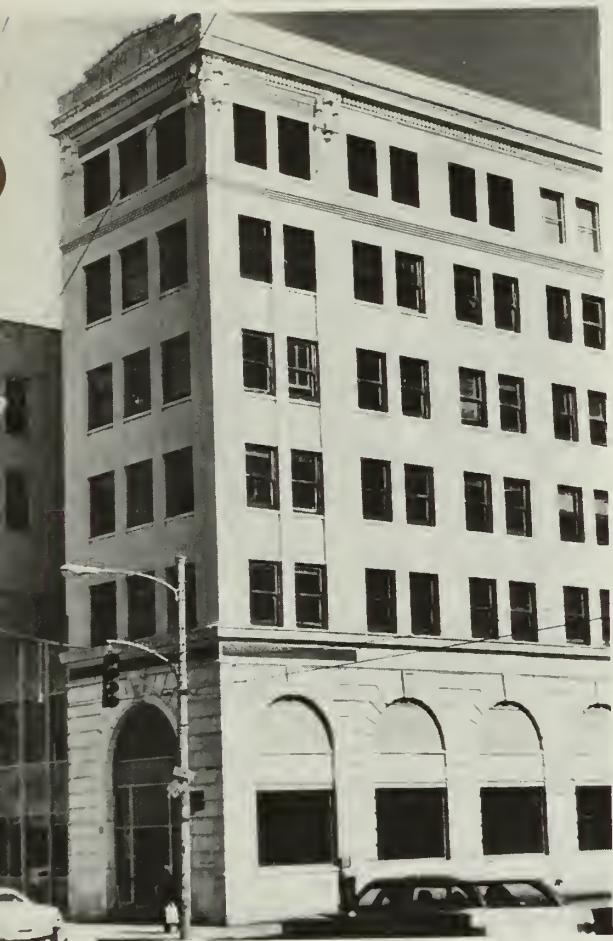
1. The original windows were of clear glazing and were of a one over one pane configuration.

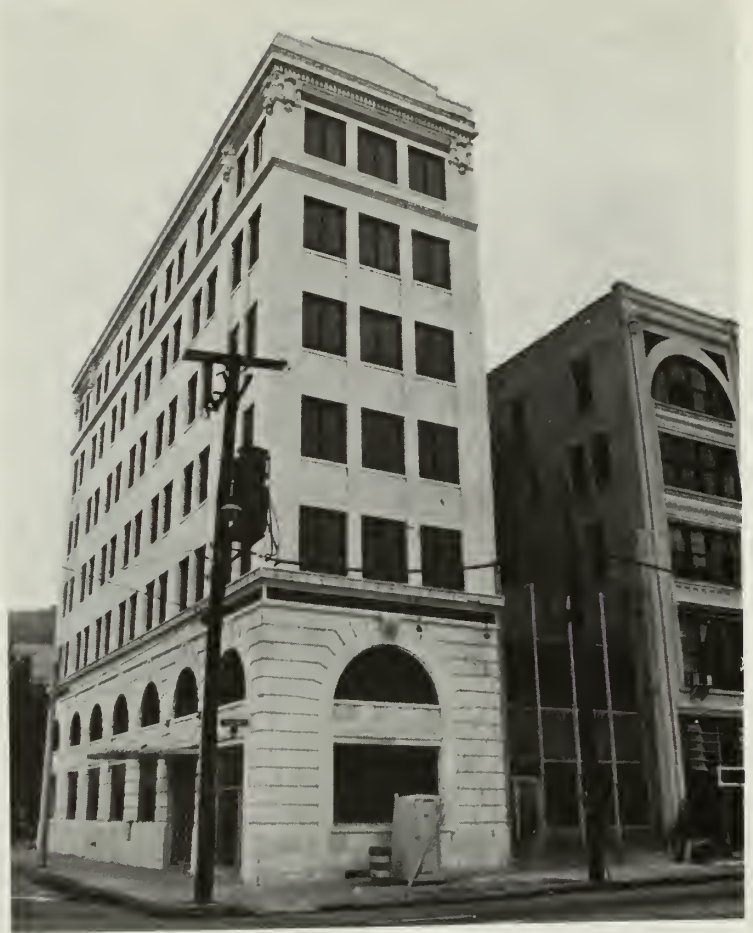
In the course of rehabilitating the building for mixed commercial and residential use, the double-hung clear-glazed wooden windows were removed (and stored) and replaced with metal windows with a single vertical division created by a meeting rail. In addition, a dark tinted glass was used in place of the original clear glazing (see illus. 2 and 3). The change in the design and the use of dark tinted glass gave the new windows a strong contemporary look not in keeping with the historic character of the building. Upon submitting a certification application, the owner was advised that the window alterations did not meet numbers 2, 5, 6 and 9 of the Secretary's Standards.

The owner was further advised by NPS that the original double-hung wooden windows were typical of the time in terms of technology and design consideration and for the building were a significant feature. As such, the windows should have been repaired and if that was not practical, the replacement units should have matched the configuration of the original double hung sash and the reflective qualities of the glass. Representatives from both the state historic preservation office and the NPS regional office inspected the completed project and observed major changes in the design and the reflective qualities of the windows. With the new dark tinted glass and dark trim finish, the windows now appear as dark voids, contrasting with the white glazed brickwork. The denial of certification by the regional office was sustained on appeal by the owner.

2. New windows with dark tinted glass and a vertical division on the upper floors were not in keeping with the character of the building.

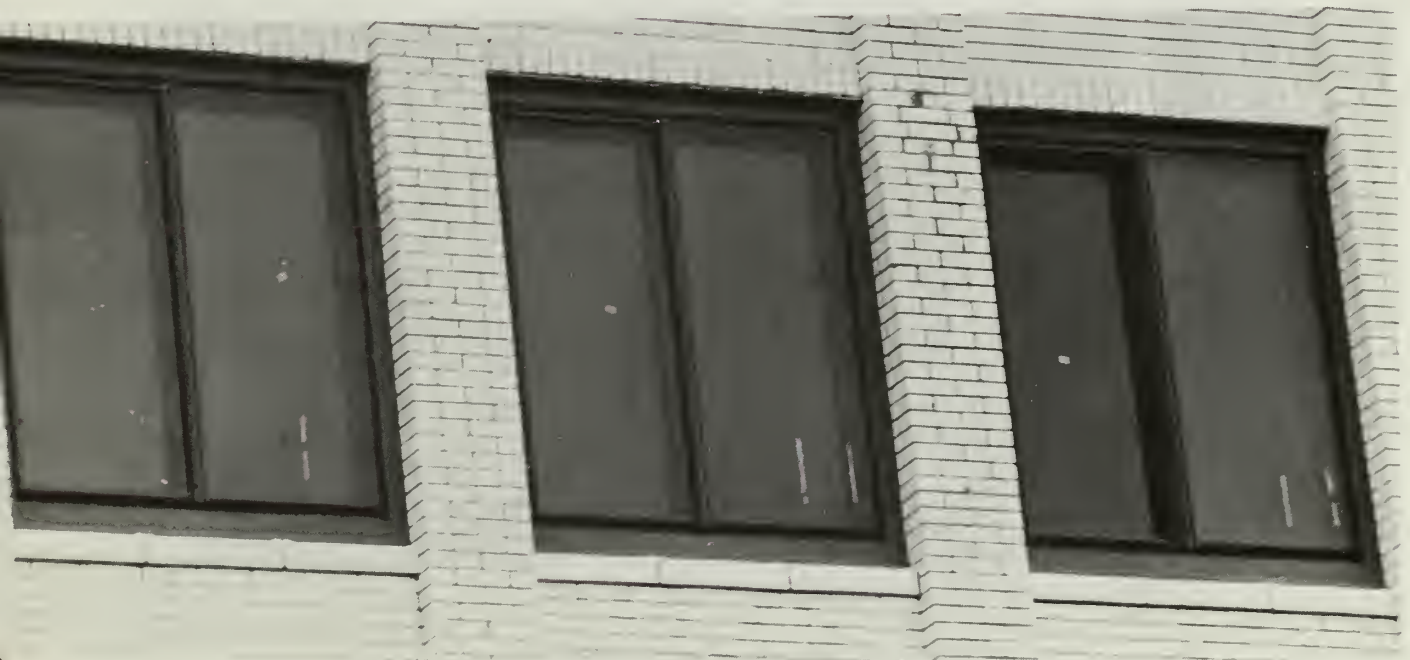
3. Close-up view shows the vertical division used in the new windows.

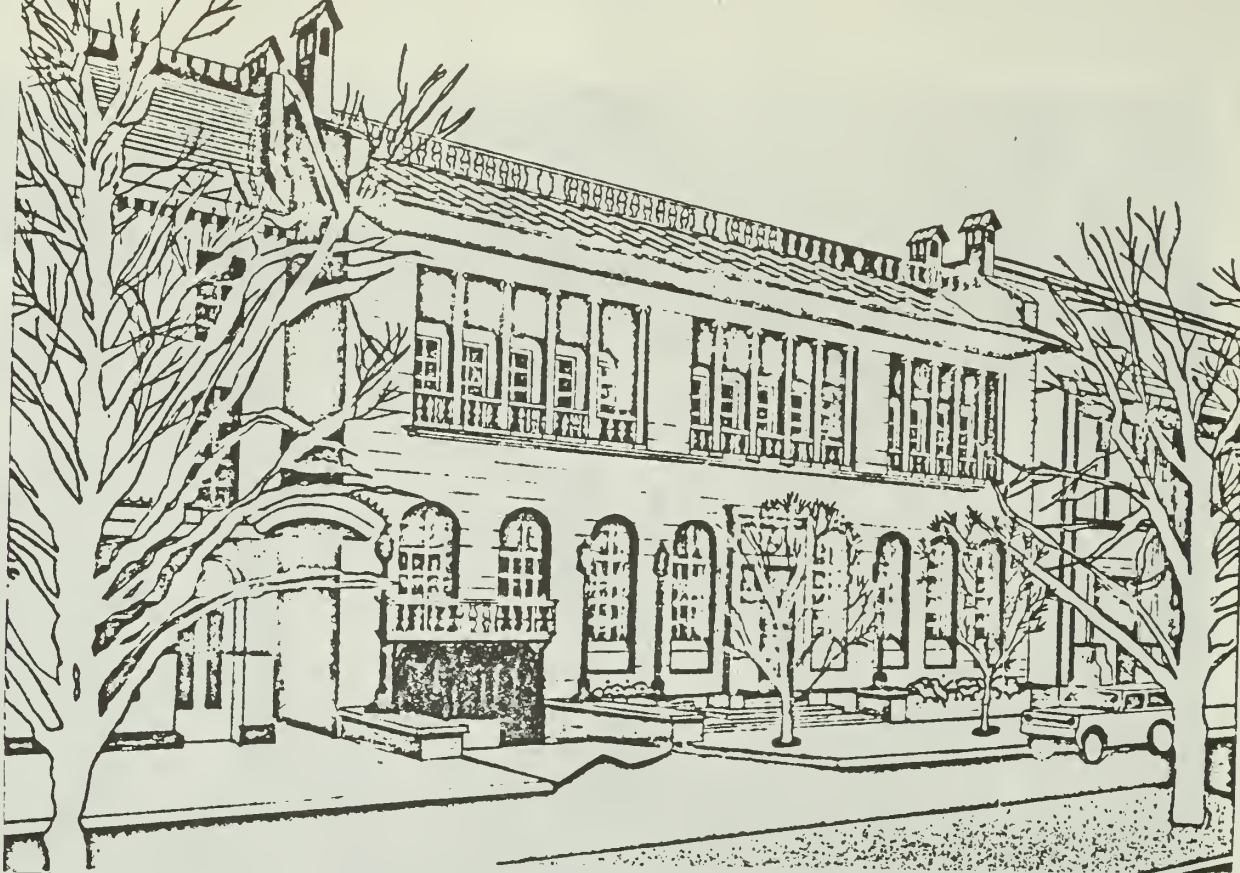
The introduction of the garage entrance on the principal facade alters the character of that well-detailed, Second Renaissance Revival-style facade. Not only does it result in the demolition and removal of historic material of significance, but it would also interrupt the rhythm and balance that is characteristic of this symmetrical facade (Standard 2). In addition, significant architectural features of the library--the bookcases, fireplace mantel, and decorative frieze--would be lost if the garage entrance is constructed as proposed (Standard 5). The Standards recommend a compatible use for a building that requires minimal alteration (Standard 1). Parking which requires a major opening on a principal facade cannot be considered a compatible use requiring minimal alterations. It is irreversible and destroys the form and integrity of that facade. The essential form and integrity of the structure should be unimpaired should alterations be removed in the future (Standard 10). While this office recognizes the arguments presented on the parking issue, the rehabilitation still must be consistent with the historic character of the structure and the Standards.

3. The original parking entrance proposed for the facade. The balustrade over the entrance was intended to serve as a visual "connector" to similar original features on the facade. The library slated for partial demolition is located behind the proposed entrance.

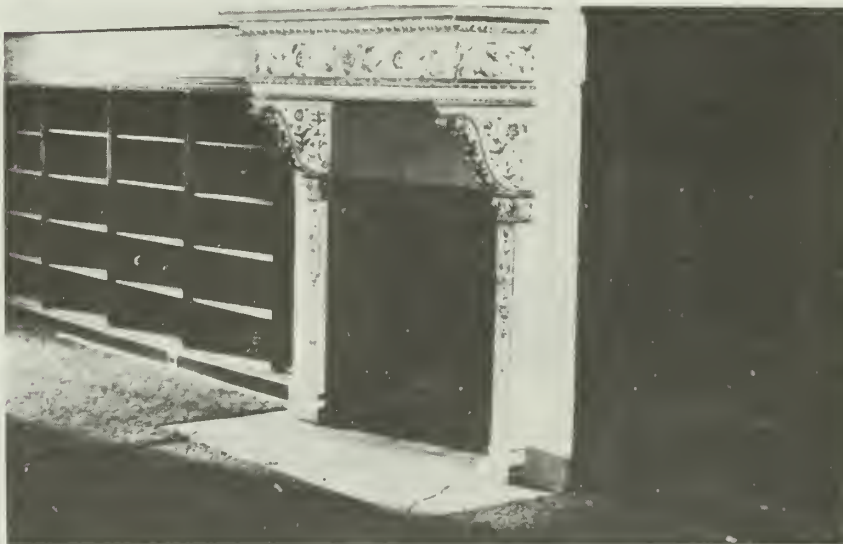
4. The parking entrance through the library would have necessitated removal of the fireplace and bookshelves.

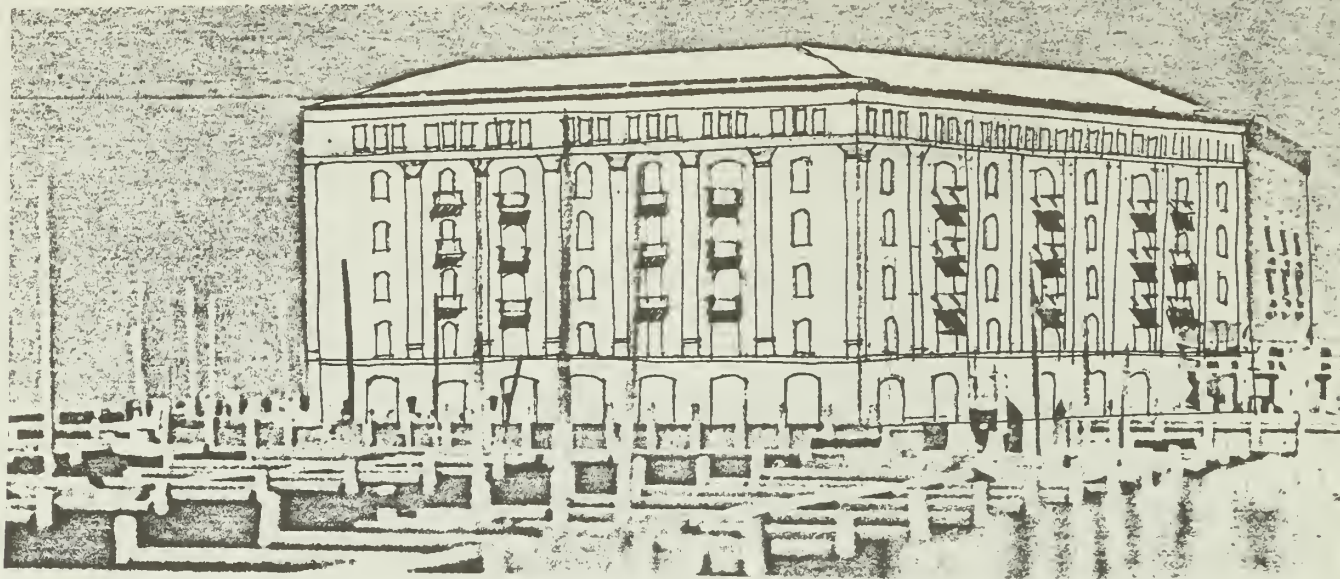
2. The proposed south elevation with bands of projecting balconies. The window openings would be widened or lengthened in order for each of the 204 apartment units to have one balcony. Not only would the windows be altered in selective bands, but the proposed balconies would create deep shadow lines on the facade. While the owner felt that the balconies were a reversible feature that could be removed in the future, the hearing officer determined that both the visual clutter of the balconies and the change in the hierarchy of the window openings did not meet the Standards.

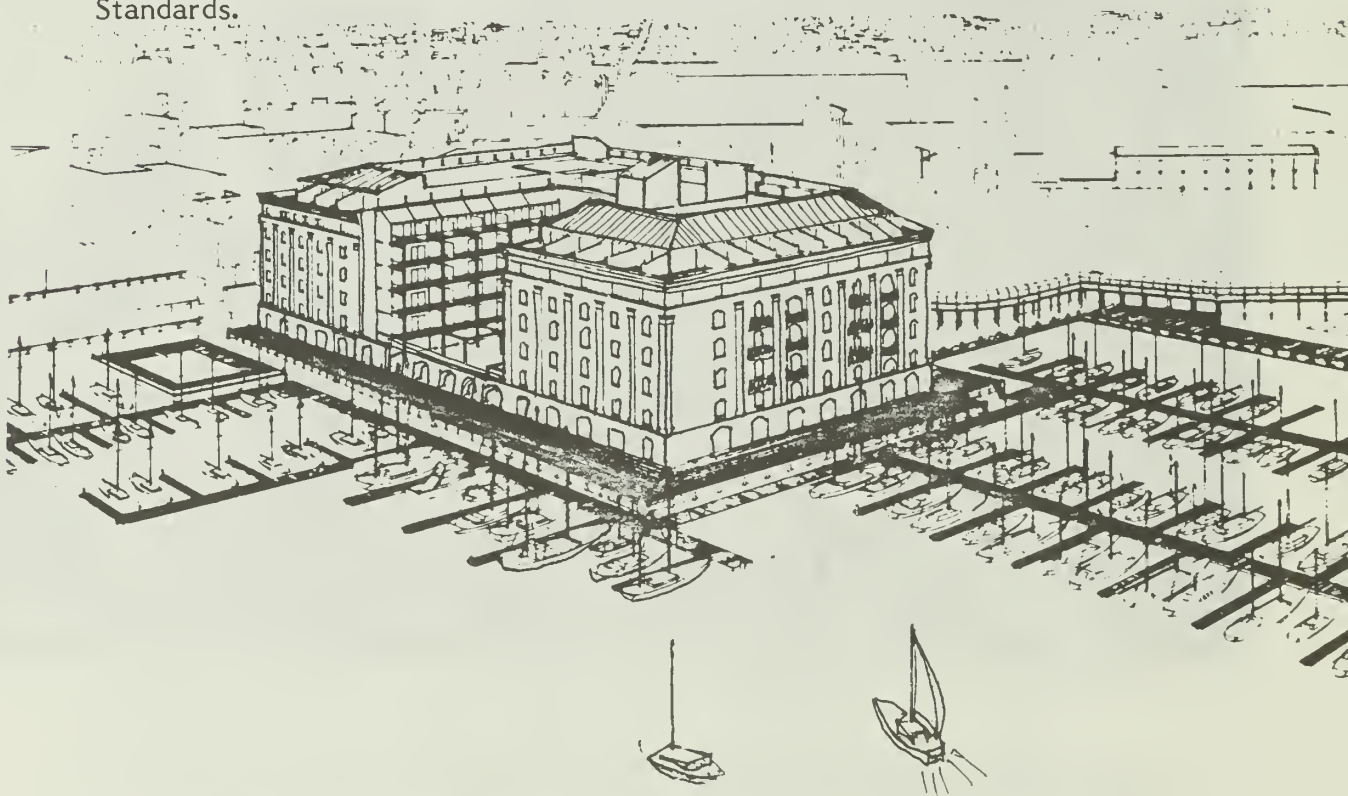
3. Perspective view of the proposed changes shows the large courtyard and the removal of seven bays of the waterfront facade in order to provide a water view for 85% of the apartment units. The hearing officer determined that the loss of significant original historic material and the drastic change in character created with the new "U" shaped plan did not meet the Standards. The projecting balconies and widened windows were also cited as not meeting the Standards. The setback rooftop addition, however, was not a concern as it would not have been visible from the street level of the historic district.

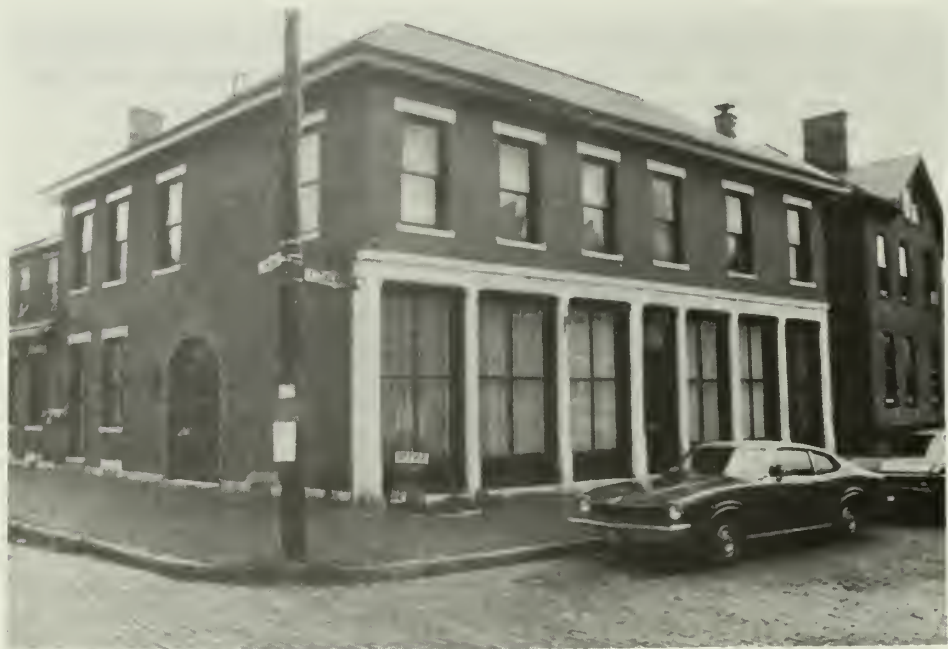
The regional office denied certification to this project, citing Standards 2, 6, and 9. The State Historic Preservation Office supported this decision. In its evaluation, the region noted that "the new arched entrance is not compatible in character with the exterior of the building as a whole, as the design of the new entrance bears no similarity to the building's other window and door openings." Equally important in the denial were the changes to the storefronts, which were "significantly altered by conversion of two, original entrances to windows and by the consequent removal of the original transoms. Although the removed doors themselves may not have been original, the placement of entrances as they were, with double doors and a transom between the windows, constituted a distinct rhythm to the storefront."

Upon appeal, the decision of the regional office was sustained. The chief appeals officer noted that the "two entrances were an important part of the commercial character and architectural detailing of the storefront facade." Furthermore, the "functional relationship of the storefront facade to the partially blank wall on the ground floor of the /side/ facade also reflected the commercial use within this portion of the building." The new entrance on this facade introduced a major new design element into the "strong rectilinear character of the building." This change further diminished the importance of the storefront to the structure.

3a. and 3b. After rehabilitation. Double doors on the front have been replaced with windows, an arched side entrance has been cut, and the former side entrance has been replaced with a window.

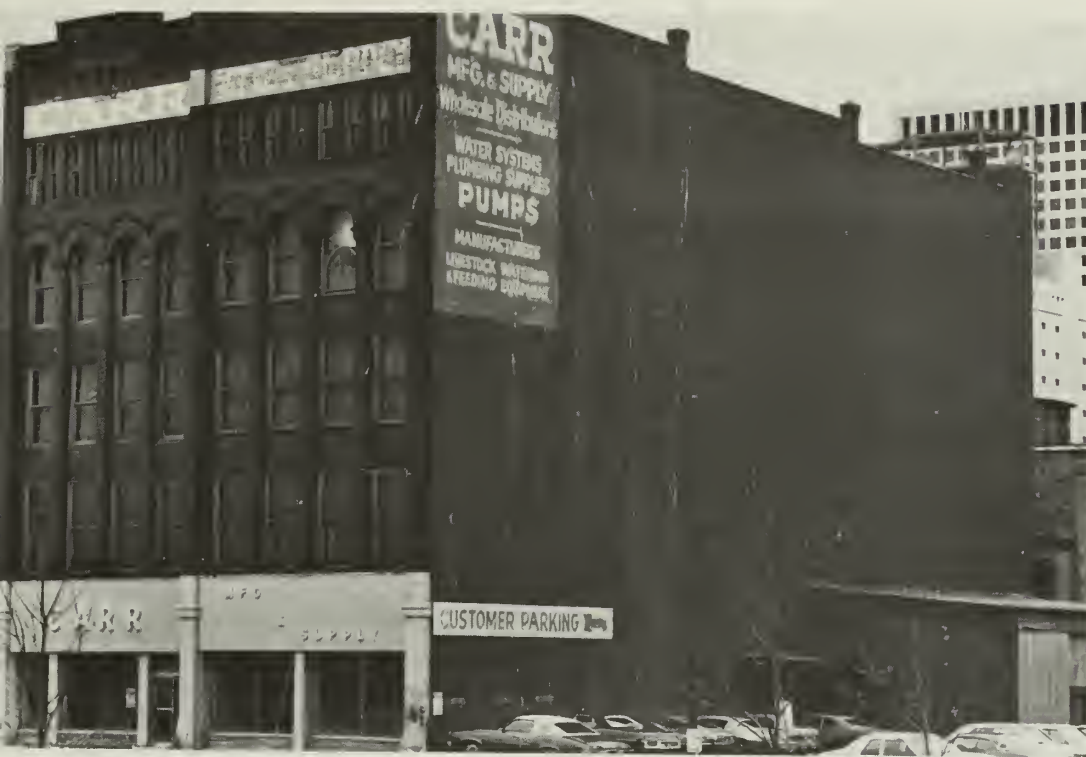
1. North and west facades of warehouse.  
The 1960's storefronts are non-significant.

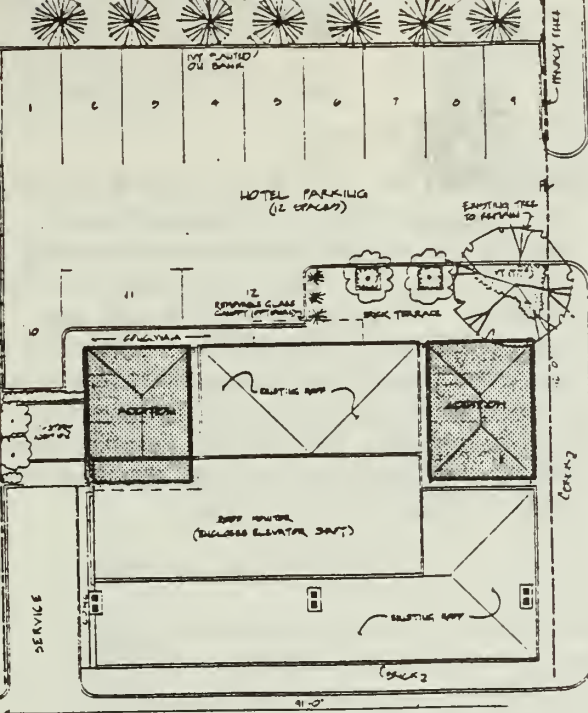
### Illustration #1. Site Plan

The proposed two rear additions would change the plan from a "T" shape to a deep rectangle. In order to preserve the characteristic proportions of the Federal era, circa 1809, plan, it was determined that the new additions read as separate structures and not as a continuation of the historic structure.

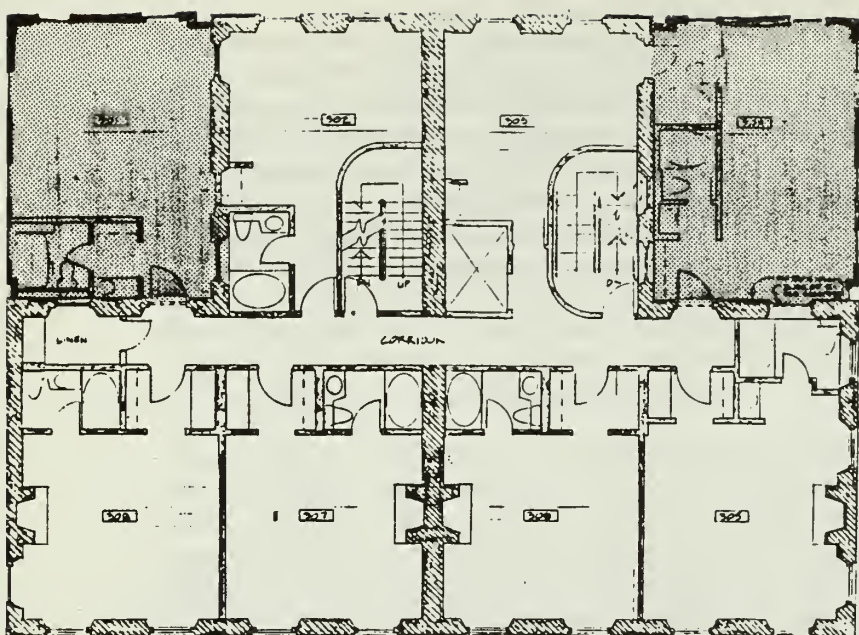
**Illustration #3. TYPICAL FLOOR PLAN.**  
The proposed infill plan (shaded) would respect the historic materials by leaving the original rear walls exposed within the new addition. The existing window and door openings would be left in place, as much as possible. In addition, recessed panels would be used as a connector infill between the original building and the additions in order to clearly differentiate the new construction from the historic structure.

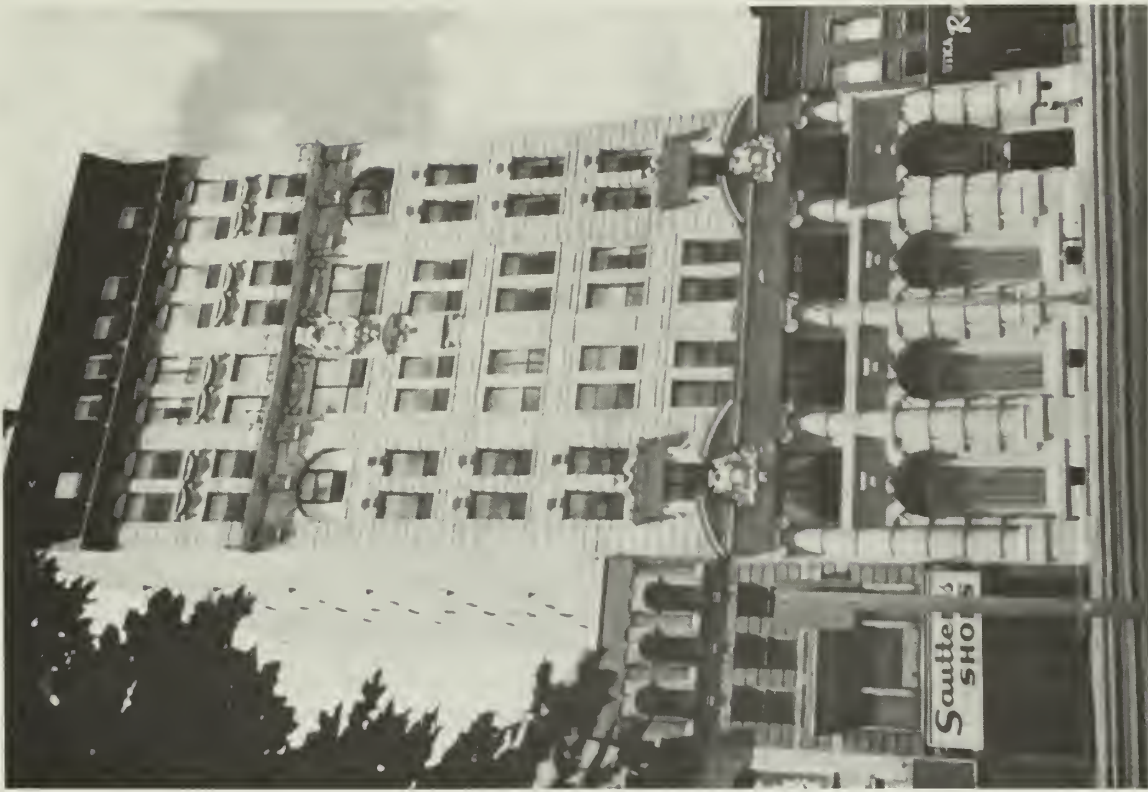
#### AFTER

Replacement sash now feature a lower meeting rail. The side lights in the arched windows were also replaced with fixed single pane glazing. The top floor is in a shadow; it was not altered by the project work.

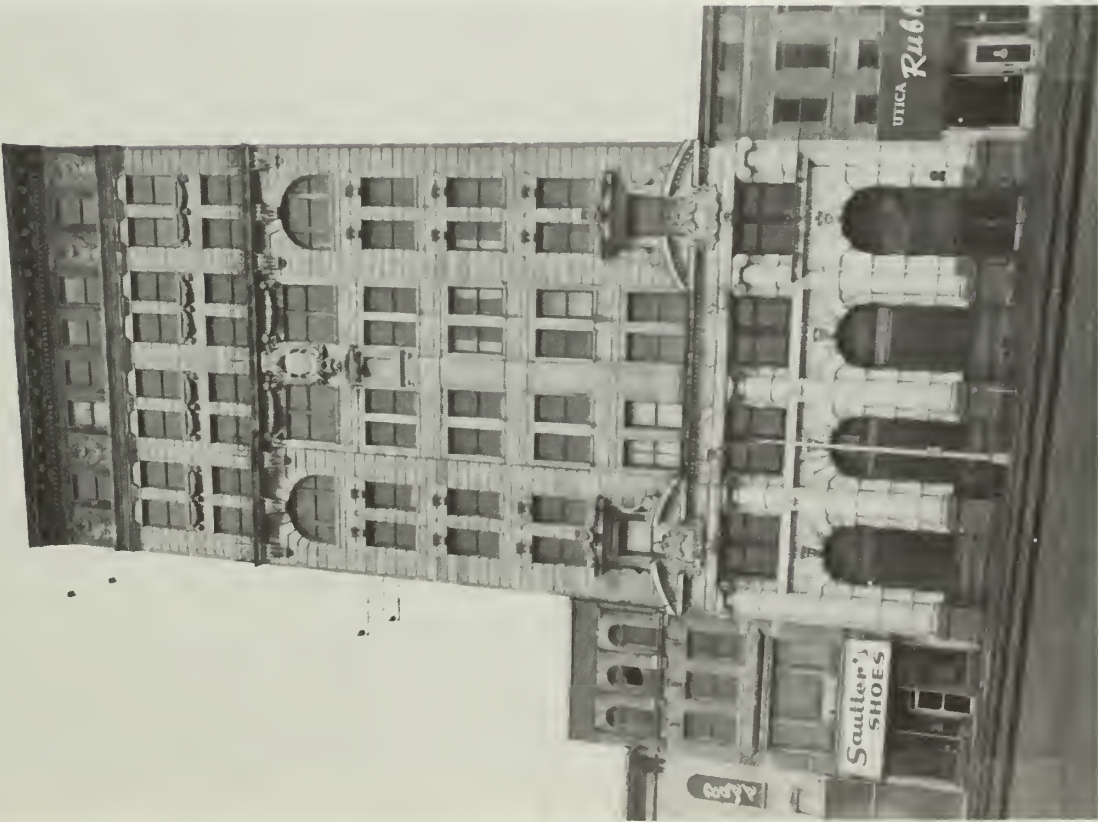
#### BEFORE

Original double hung window sash featured a mid-level, horizontal meeting rail.

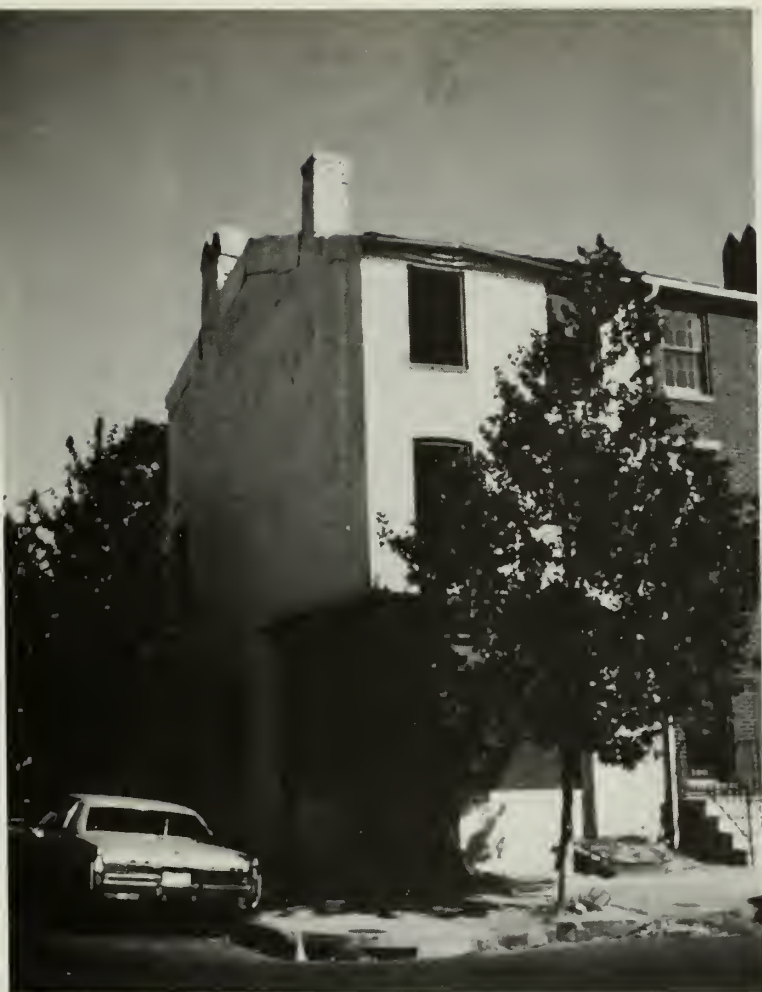
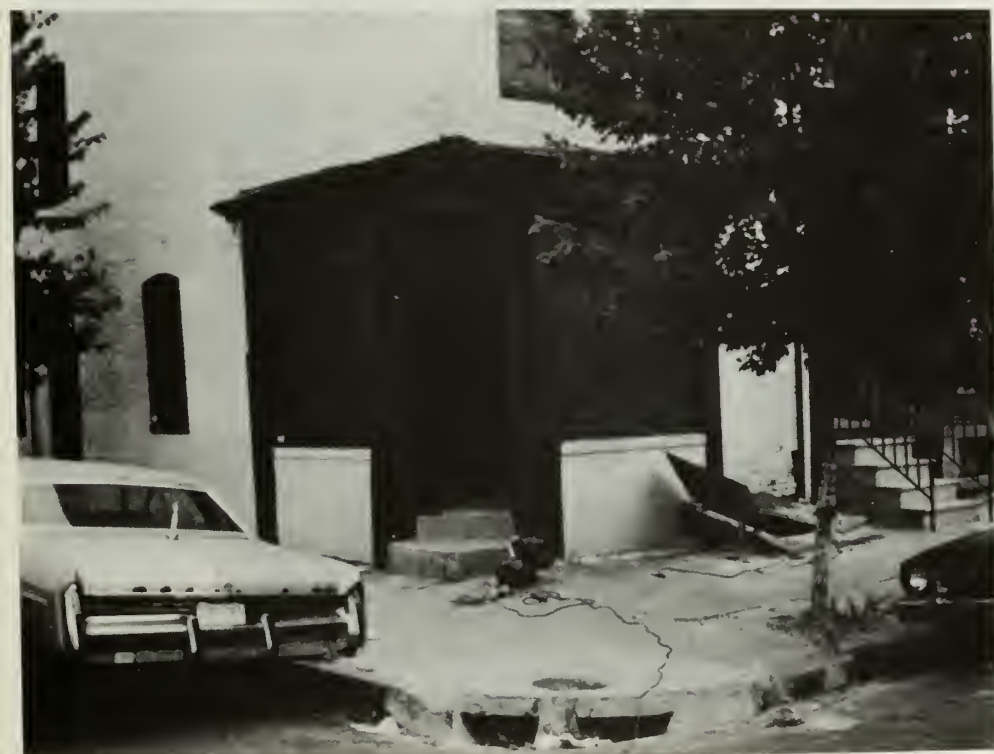
1. and 2. Before rehabilitation. The corner grocery store had its original diagonal entrance and flanking plate glass windows. Although the storefront remained intact, the base had been filled with brick and the plate glass boarded over.

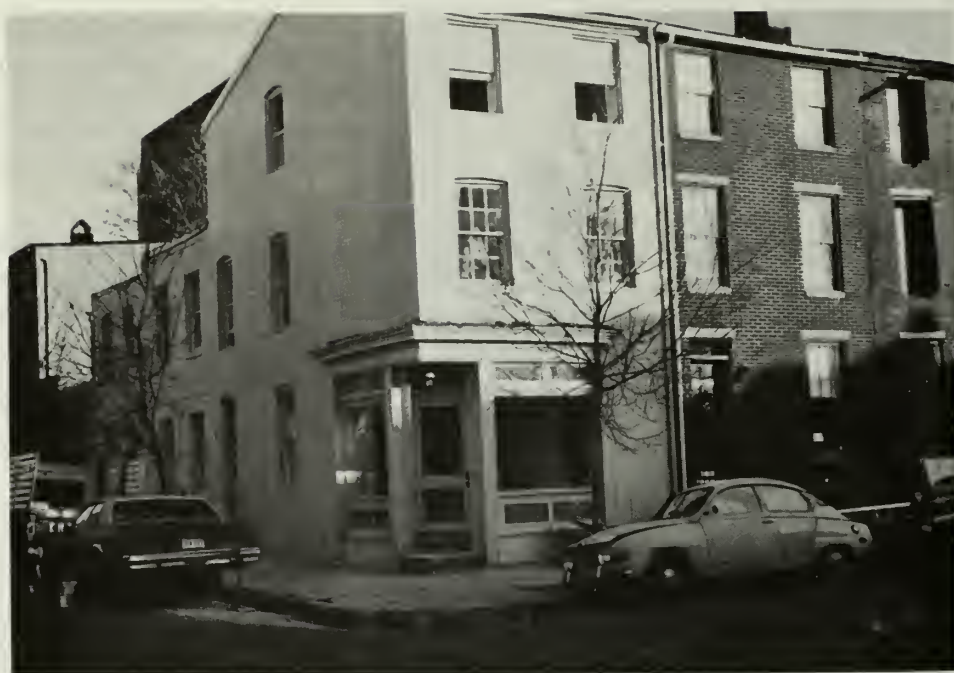
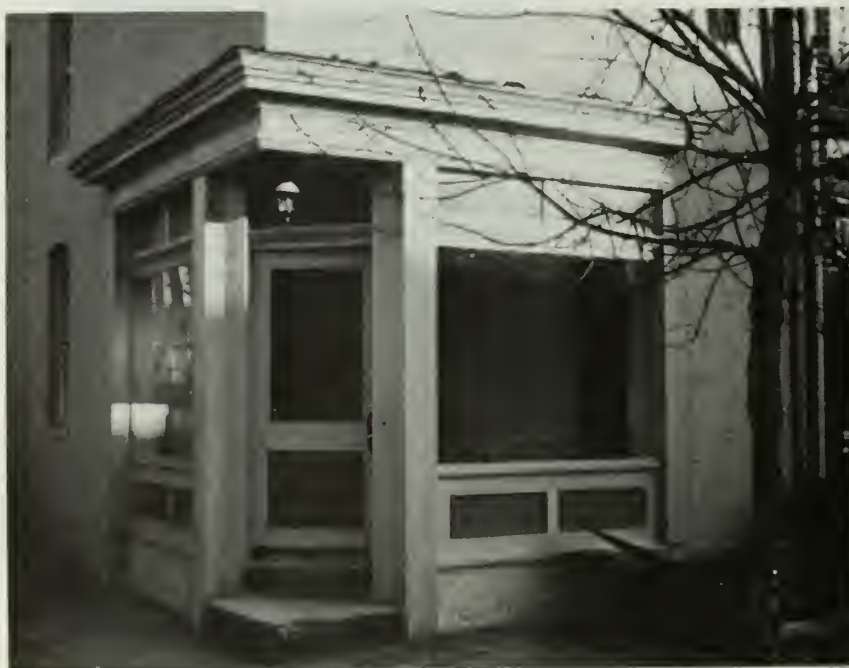
3. and 4. After rehabilitation. In rehabilitating the original storefront, the owner installed plate glass in the large openings and transoms and replaced the brick infill with wooden panels. By retaining significant architectural features, the commercial character of the building was retained.

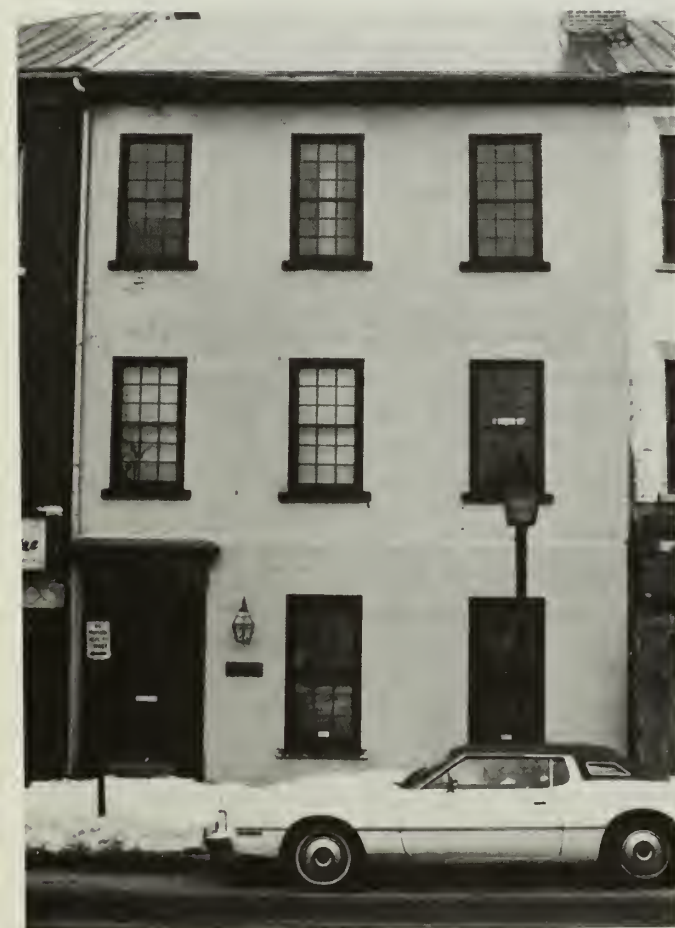
6. After rehabilitation. The building exhibits residential scale windows and door openings on the ground floor. This alteration results in a loss of the building's commercial character and an interruption in the commercial row.

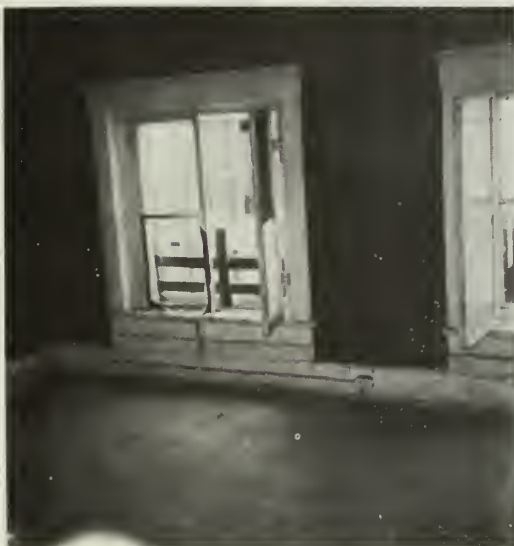
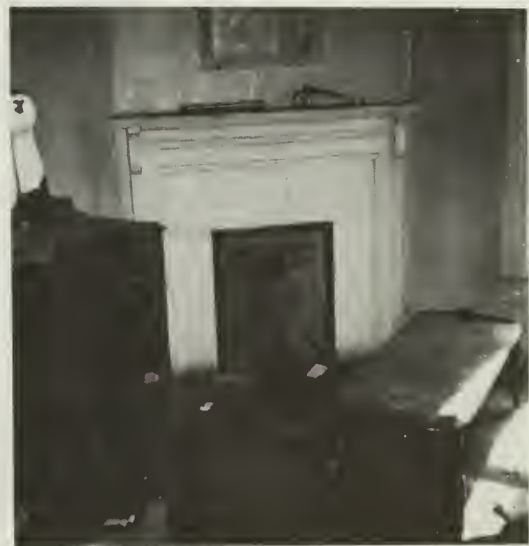
2. Modest interior detailing, such as window and baseboard trim, and diagonally placed mantels contribute to the historic character of the 1894 townhouse and thus should have been preserved to the greatest extent possible.

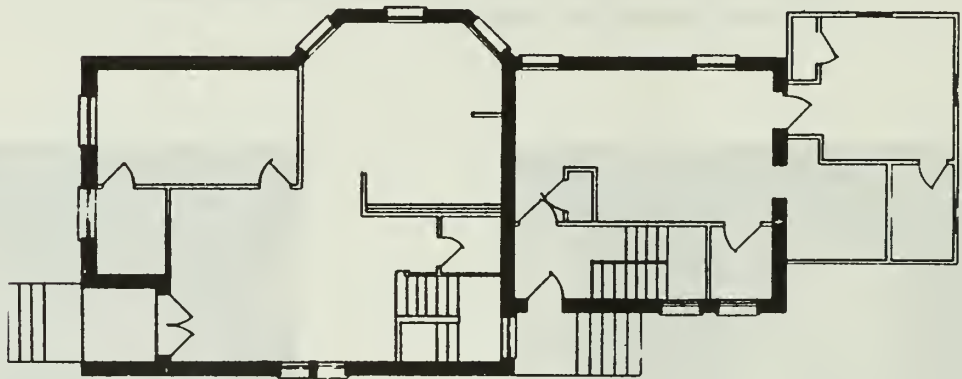
PROPOSED FLOOR PLAN

4. Interior work involved demolition of existing partitions as well as relocation of the living area to the historic entrance and stair hall space (see illus. 3). The rearrangement of rooms led to removal of corner mantels, baseboards, and door and window trim (see illus. 2). Because the character-defining interior spaces, features, and materials were not sufficiently preserved, the entire project failed to meet the Standards, despite qualifying exterior work.

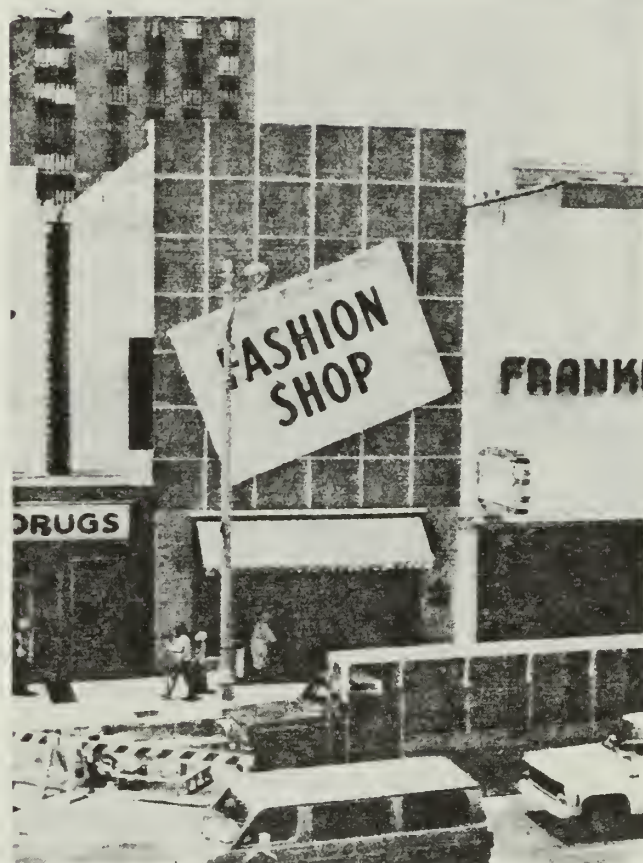
2. A 1967 storefront alteration involved installation of a stucco false front on the upper levels; stone at the ground level had been removed as the result of the installation of an aluminum and glass entry in the 1950s.

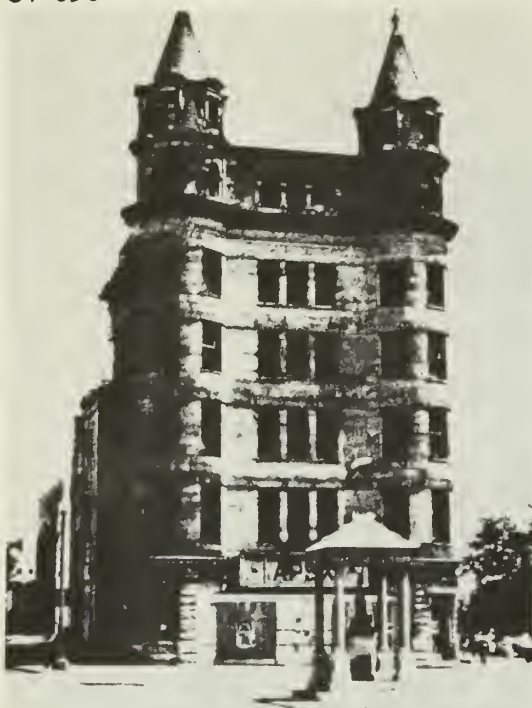
1. This photograph of the west elevation shows the 1880 addition of flush ashlar brownstone above the rough-cut brownstone of the first floor. Because the historic brownstone on this wall was basically sound, only repainting was required.
